# TECHNICAL MEMORANDUM

**PROJECT:** Dunvegan Recreation Building  
**DATE:** May 28<sup>th</sup>, 2026  
**TO:** Stephanie MacRae  
**FROM:** Jordan Gandia, P.Eng.  
**RE:** Structural Inspection and Condition Assessment – Floor Structure  
**Project #:** 26053

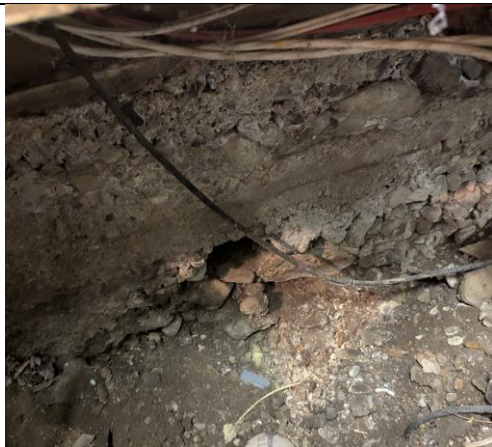
No issues were observed on the exterior of the foundation above grade. In the crawl space, the exterior foundation wall exhibited locations of medium to severe honeycombing.

FIGURE 5: Honeycombing

The areas of medium to severe honeycombing can be repaired when work on the floor structure is being performed (low priority).

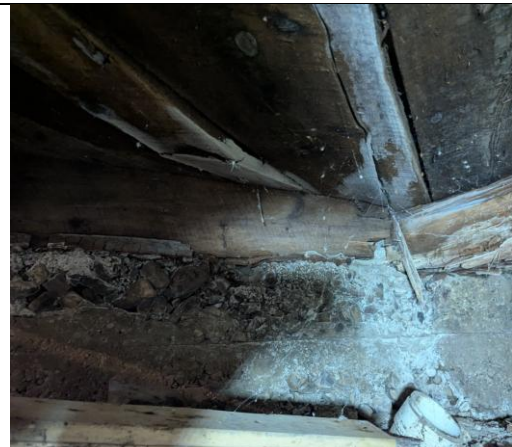
Medium to severe brown rot was observed at various locations on the timber beams, up to approximately 25mm deep. In one location near the hatch, very severe brown rot penetrated into the core of the beam.

What appeared to be light to medium white rot was observed on some of the timber beams and decking. One of the deck boards near the hatch that exhibited white rot had failed in bending.

FIGURE 6: White and Brown Rot

It is recommended that timber beams and floorboards exhibiting severe or very severe rot be either strengthened or replaced (high priority). Construction in the crawl space is unlikely to be feasible with the current hatch opening. The current observed rot is in timber beams supporting portions of the southern partition walls; it is expected that at least some of the partition walls and supporting floor structure will have to be demolished to access below.

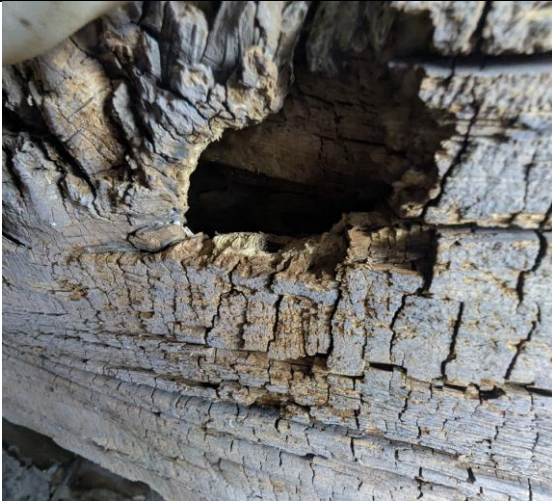
*FIGURE 7: Very Severe Rot*

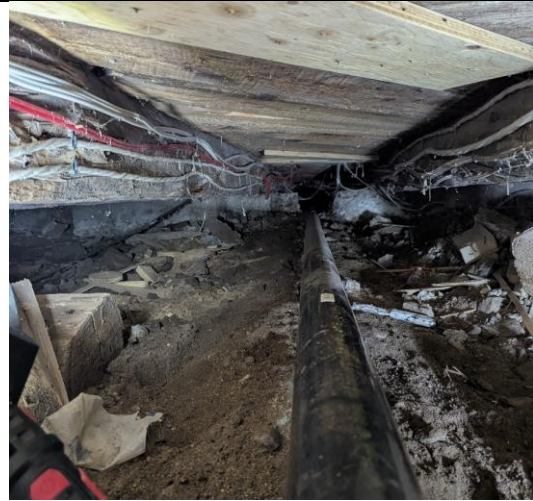
The inspection was limited to a visual assessment of accessible areas. The crawl space is accessible from a hatch in the floor along the east wall. The crawl space itself provides about 300 to 400mm of room to move around; however, the presence of construction debris, including nails, as well as barbed wire, prevented access to the North and West sides of the crawl space. Two gratings were removed to allow observation beneath the stage on the North end of the building.

*FIGURE 8: Crawl space*

Due to the difficulty accessing deeper into the crawl space, the scope of the work is difficult to fully assess. It is suggested that when the hardwood flooring is removed, that locations of floorboards in poor condition be removed to allow better access to the crawl space. At that time, the scope of the repair work may be better defined, and consideration may be given to preserving the stage area at the North end of the building. In the meantime, the Township should consider budgeting to repair/replace the entire floor structure.

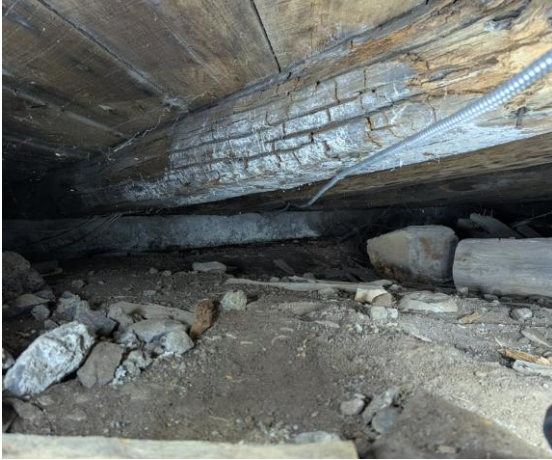
*FIGURE 9: Timber Beam Rot*

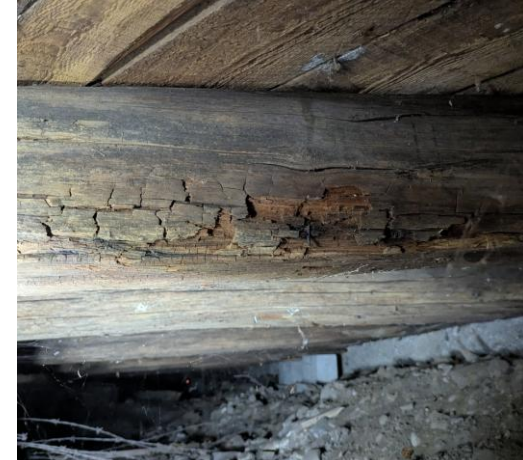
*FIGURE 10: Timber Beam Rot*

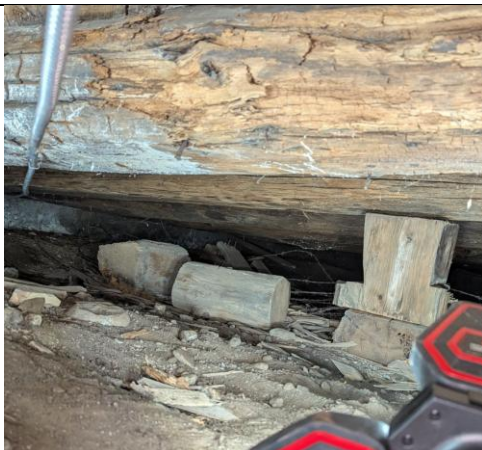
The floor structure is composed of timber beams spaced approximately 1220mm o.c. (varies), supporting 25mm thick diagonally placed boards. The timber beams vary in size; one was measured to be approximately 300mm wide by 200mm tall. Cut timber pieces have been propped up under the quarter spans of the timber beams; many of these makeshift posts have since fallen. The floor structure is continuous throughout the interior of the building, supporting the partition walls at the South end and the stage at the North end.

*FIGURE 11: Makeshift Timber Post*

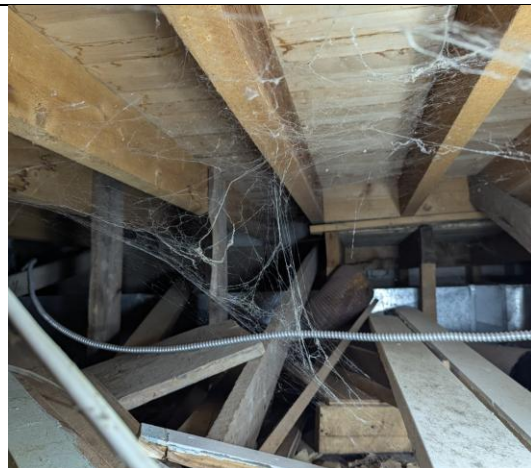
The stage framing was observed through two gratings. The floor of the stage is composed of nominal 2x6 joists (51x150mm), spaced at 356mm o.c. The span of these joists is approximately 3048mm. Many of the joists were supported at midspan by what appeared to be 25x140 lumber posts, resting on the floor below.

*FIGURE 12: Stage Floor Structure*
