THE CORPORATION OF THE TOWNSHIP OF NORTH GLENGARRY Regular Meeting of Council Agenda

Monday, January 9, 2023, 6:00 p.m.
Council Chamber
3720 County Road 34
Alexandria, On. K0C 1A0

NORTH GLENGARRY LCB ROADS INVESTIGATION

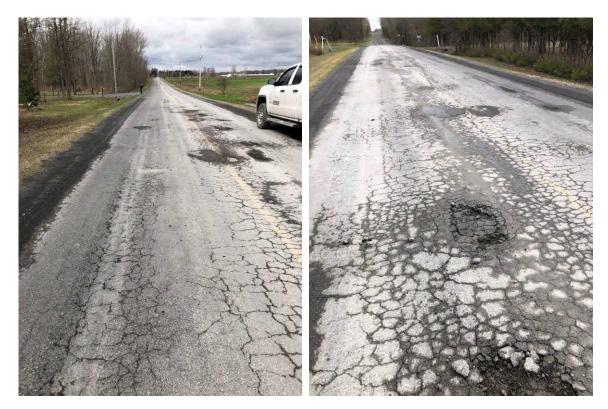
Figure 4.1.1: Location A, Typical Road Section

Photographs of typical conditions, showing the above distresses are included in Figure 4.1.1.

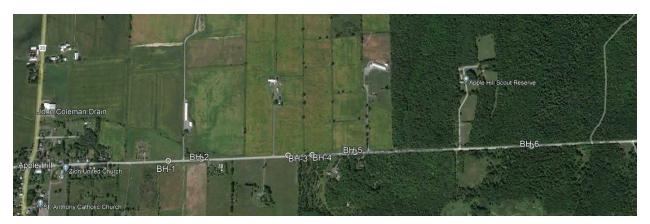
Figure 4.1.2: Location A, Borehole Locations

Figure 4.1.2, below, shows the approximate subject road investigation limits with the locations of boreholes advanced during the investigation, as collected via GPS.

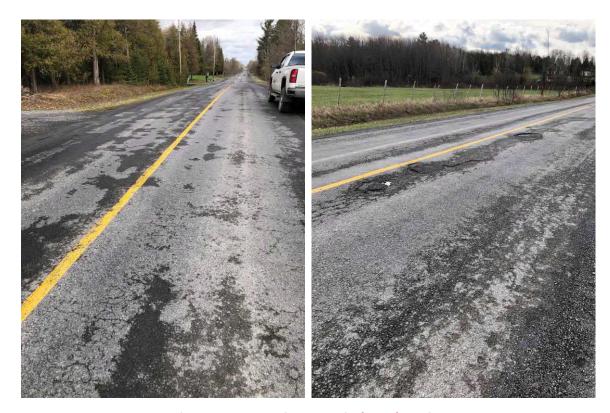
Figure 4.2.1: Location B, Typical Road Section

Photographs of typical conditions, showing the above distresses are included in Figure 4.2.1.

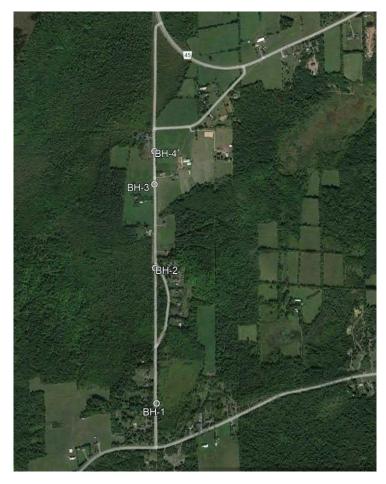
Figure 4.2.2: Location B, Borehole Locations

Figure 4.2.2, below, shows the approximate subject road investigation limits with the locations of boreholes advanced during the investigation, as collected via GPS.

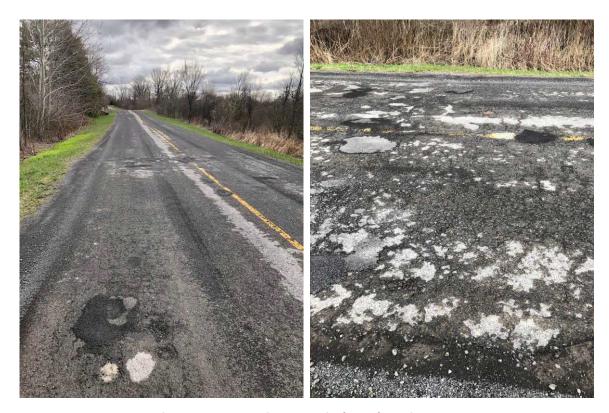
Figure 4.3.1: Location C, Typical Road Section

Photographs of typical conditions, showing the above distresses are included in Figure 4.3.1.

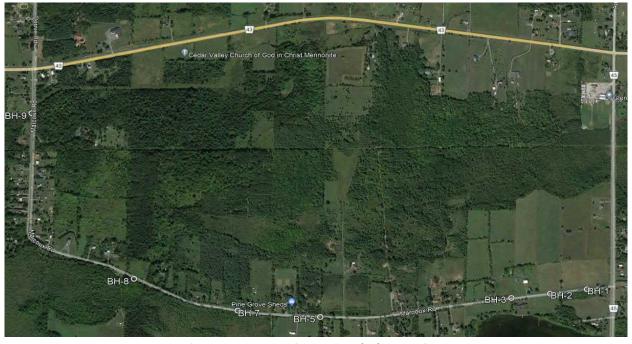
Figure 4.3.2: Location C, Borehole Locations

Figure 4.3.2, below, shows the approximate subject road investigation limits with the locations of boreholes advanced during the investigation, as collected via GPS.

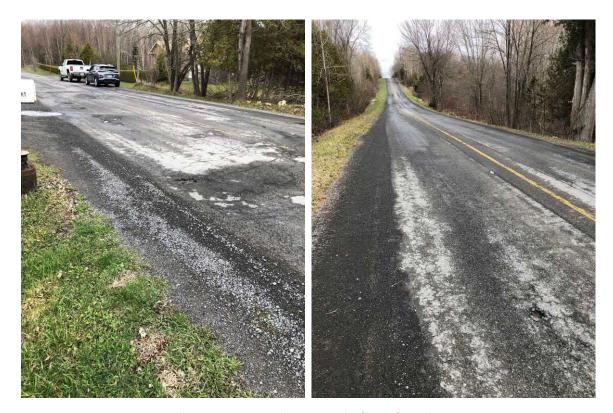
Figure 4.4.1: Location D, Typical Road Section

Photographs of typical conditions, showing the above distresses are included in Figure 4.4.1.

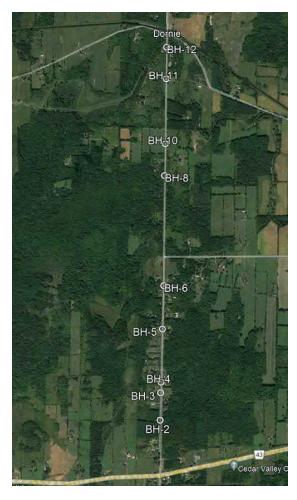
Figure 4.4.2: Location D, Borehole Locations

Figure 4.4.2, below, shows the approximate subject road investigation limits with the locations of boreholes advanced during the investigation, as collected via GPS.

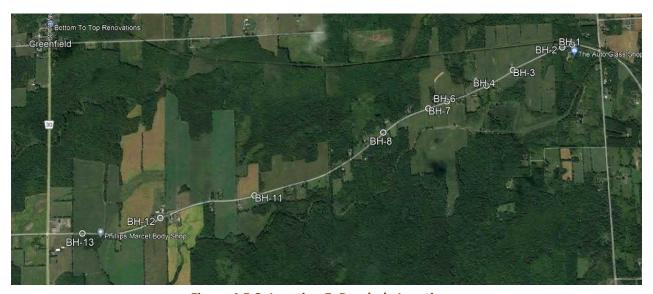
Figure 4.5.2: Location E, Borehole Locations

Figure 4.5.2, below, shows the approximate subject road investigation limits with the locations of boreholes advanced during the investigation, as collected via GPS.

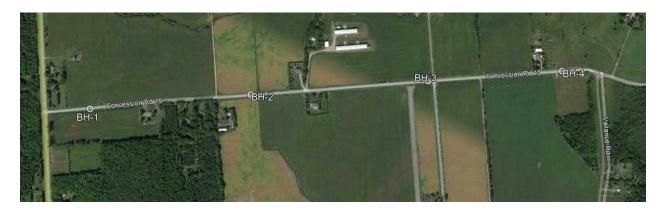
Figure 4.6.3: Location F, Borehole Locations

Figure 4.6.2, below, shows the approximate subject road investigation limits with the locations of boreholes advanced during the investigation, as collected via GPS.

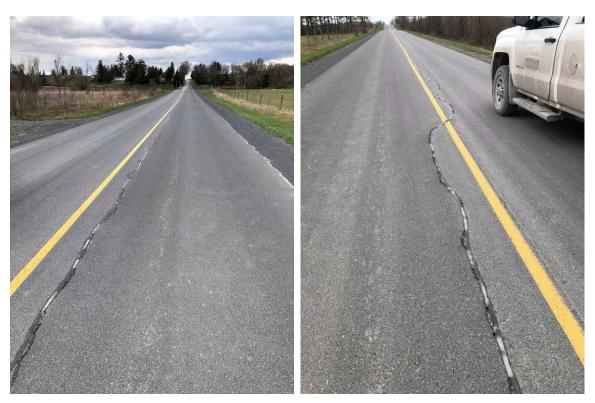
Figure 4.7.1: Location G, Typical Road Section

From a discussion with the Township, the existing surface course on this road is approximately 2 years old. The most recent treatment involved a 50 mm overlay, and crack sealing one year ago. The road is generally in good condition, except for the single meander crack that can be observed throughout. Photographs showing the condition of River Road are included in Figure 4.7.1 below.

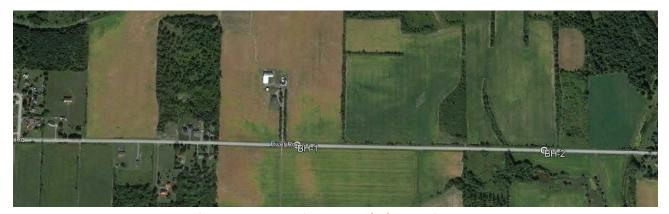
Figure 4.7.2: Location G, Borehole Locations

Figure 4.7.2, below, shows the approximate subject road investigation limits with the locations of boreholes advanced during the investigation, as collected via GPS.

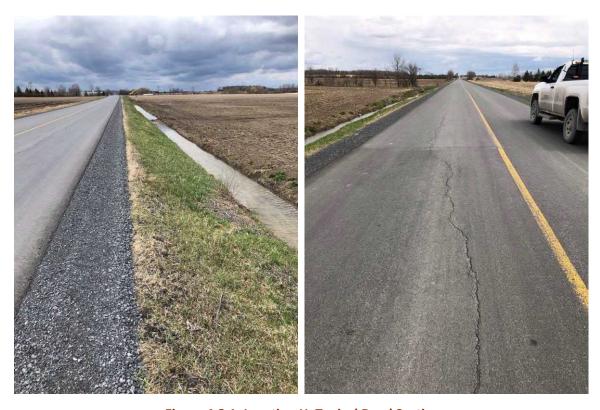
Figure 4.8.1: Location H, Typical Road Section

From discussion with the Township, the existing surface course on this road is approximately 1 year old. The most recent treatment involved expanded asphalt recycling. The road is generally in good condition, except for the single meander crack that can be observed throughout. Photographs showing the condition of River Road are included in Figure 4.8.1 below.

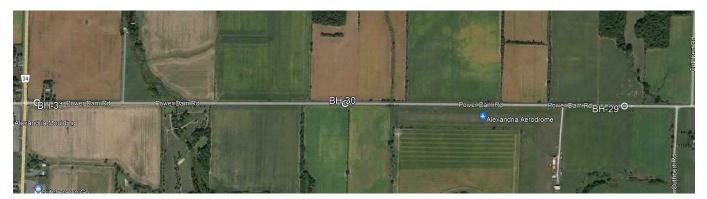
Figure 4.8.2: Location H, Borehole Locations

Figure 4.8.2, below, shows the approximate subject road investigation limits with the locations of boreholes advanced during the investigation, as collected via GPS.

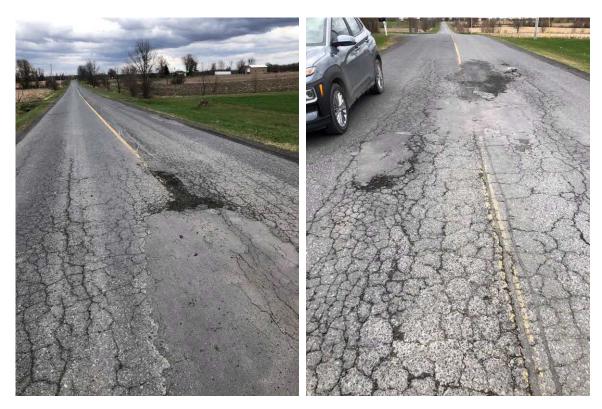
Figure 4.9.1: Location I, Typical Road Section

The condition of McCormick Road is pictured in Figure 4.9.1.

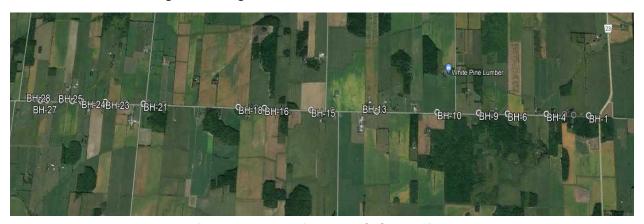
Figure 4.9.2: Location I, Borehole Locations

Figure 4.9.2, below, shows the approximate subject road investigation limits with the locations of boreholes advanced during the investigation, as collected via GPS.

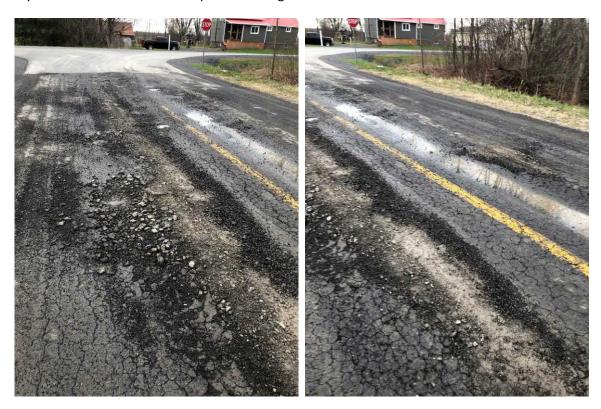
Figure 4.10.1: Location J, Severe Frost Heave

The section on Concession 16 is limited to a very severe frost heave just west of where the road meets County Road 20. The frost heave is pictured in Figure 4.10.1.

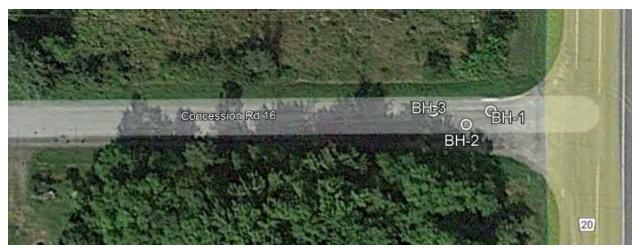
Figure 4.10.2: Location J, Borehole Locations

Figure 4.10.2, below, shows the approximate subject road investigation limits with the locations of boreholes advanced during the investigation, as collected via GPS.

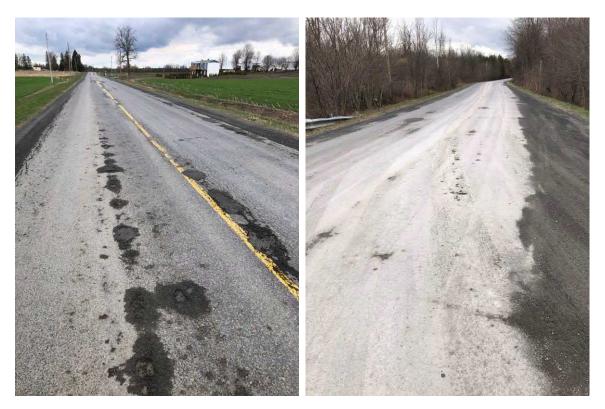
Figure 4.11.1: Location K, Typical Road Section

The condition of Concession Road 8 is pictured in Figure 4.11.1.

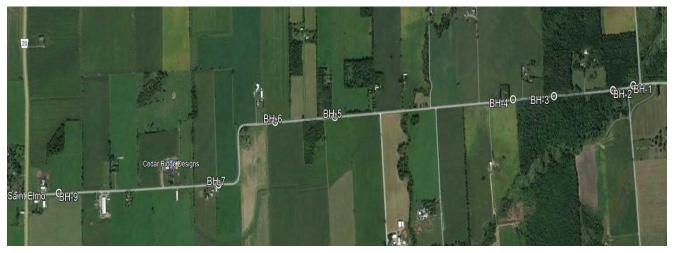
Figure 4.11.2: Location K, Borehole Locations

Figure 4.11.2, below, shows the approximate subject road investigation limits with the locations of boreholes advanced during the investigation, as collected via GPS.

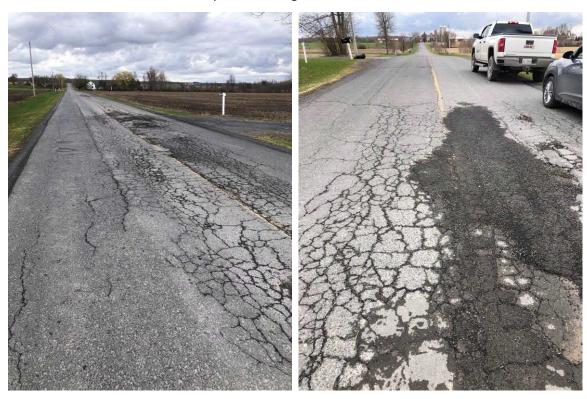
Figure 4.12.1: Location L, Typical Road Section

The condition of Concession Road 8 is pictured in Figure 4.12.1.

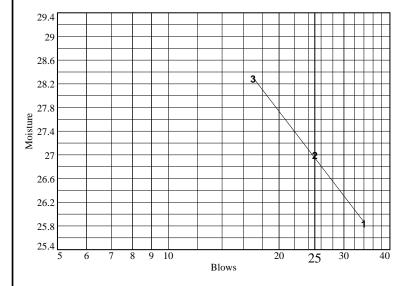
Liquid Limit= _	26.9
Plastic Limit= _	14.8
Plasticity Index= _	12.1
Natural Moisture=	13.5
Liquidity Index=	-0.1

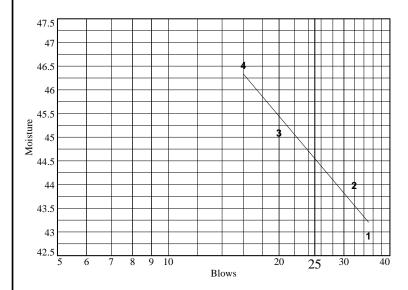
Liquid Limit= _	44.5
Plastic Limit= _	21.6
Plasticity Index= _	22.9
Natural Moisture= _	24.5
Liquidity Index=	0.1

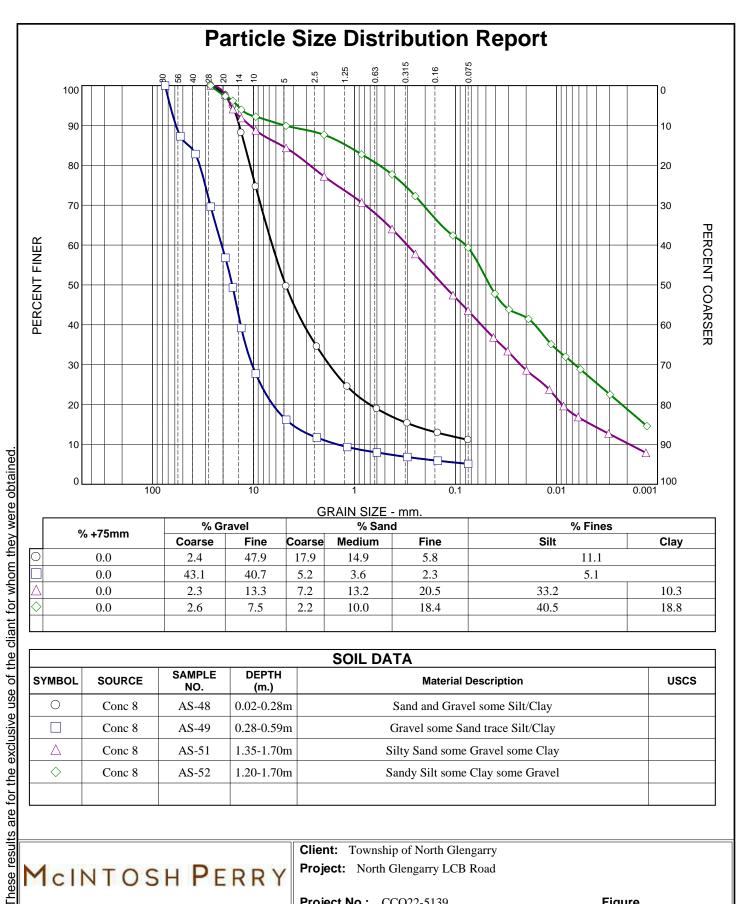
% +75mm		% Gravel		% San	d	% Fines		
	Coarse	Fine	Coarse	Medium	Fine	Silt	Clay	
0.0	2.4	47.9	17.9	14.9	5.8	11.1		
0.0	43.1	40.7	5.2	3.6	2.3	5.1		
0.0	2.3	13.3	7.2	13.2	20.5	33.2	10.3	
0.0	2.6	7.5	2.2	10.0	18.4	40.5	18.8	
	0.0	0.0 2.4 0.0 43.1 0.0 2.3	0.0 2.4 47.9 0.0 43.1 40.7 0.0 2.3 13.3	0.0 2.4 47.9 17.9 0.0 43.1 40.7 5.2 0.0 2.3 13.3 7.2	0.0 2.4 47.9 17.9 14.9 0.0 43.1 40.7 5.2 3.6 0.0 2.3 13.3 7.2 13.2	0.0 2.4 47.9 17.9 14.9 5.8 0.0 43.1 40.7 5.2 3.6 2.3 0.0 2.3 13.3 7.2 13.2 20.5	0.0 2.4 47.9 17.9 14.9 5.8 11.1 0.0 43.1 40.7 5.2 3.6 2.3 5.1 0.0 2.3 13.3 7.2 13.2 20.5 33.2

SOIL DATA											
SYMBOL	SOURCE	SAMPLE NO.	DEPTH (m.)	Material Description	uscs							
0	Conc 8	AS-48	0.02-0.28m	Sand and Gravel some Silt/Clay								
	Conc 8	AS-49	0.28-0.59m	Gravel some Sand trace Silt/Clay								
Δ	Conc 8	AS-51	1.35-1.70m	Silty Sand some Gravel some Clay								
\Diamond	Conc 8	AS-52	1.20-1.70m	Sandy Silt some Clay some Gravel

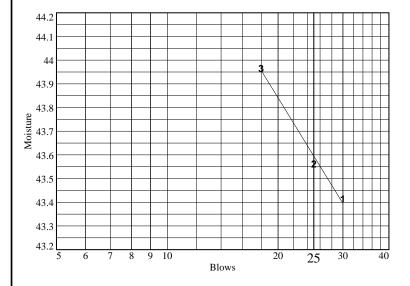
Liquid Limit= _	43.6
Plastic Limit= _	21.5
Plasticity Index=	22.1
Natural Moisture= _	29.8
Liquidity Index=	0.4

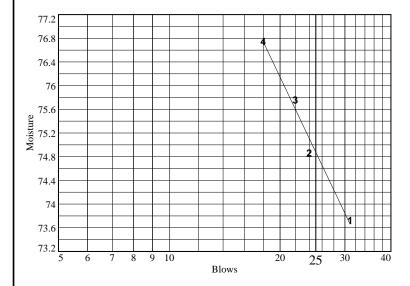
Liquid Limit=	74.9
Plastic Limit=	29.4
Plasticity Index=	45.5
Natural Moisture=	37.6
Liquidity Index=	0.2

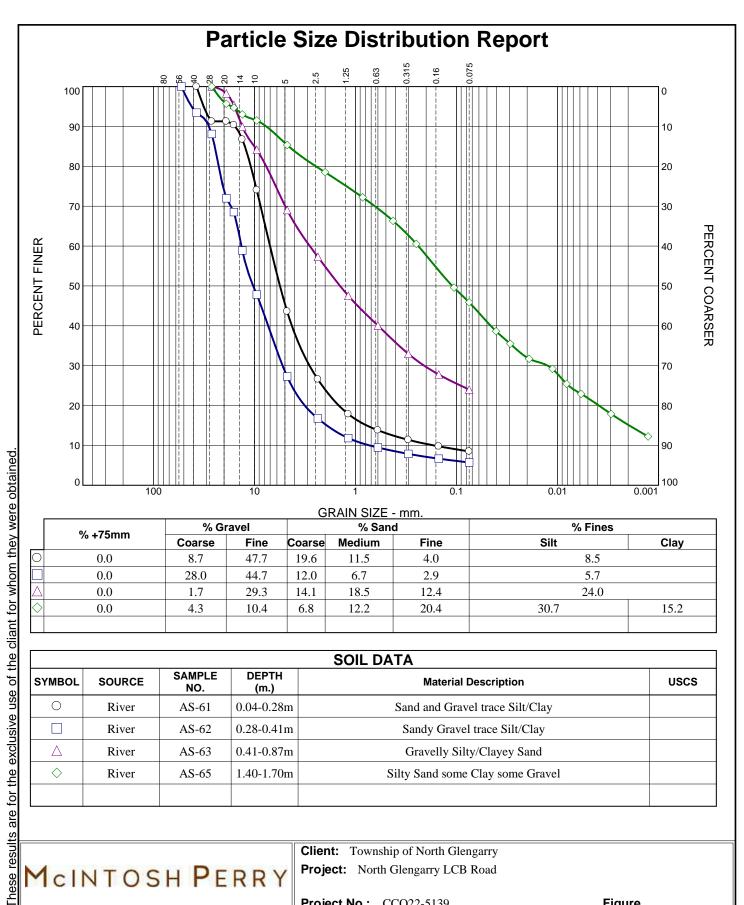
% +75mm	% Gravel			% San	d	% Fines		
	70 +7 3HHH	Coarse	Fine	Coarse Medium Fi		Fine	Silt	Clay	
	0.0	8.7	47.7	19.6	11.5	4.0	8.5		
	0.0	28.0	44.7	12.0	6.7	2.9	5.7		
7	0.0	1.7	29.3	14.1	18.5	12.4	24.0		
>	0.0	4.3	10.4	6.8	12.2	20.4	30.7	15.2	
				100			2 3 3 7

SOIL DATA	
SYMBOL	MBOL SOURCE SAMPLE DEPTH (m.) Material Description		Material Description	uscs	
0	River	AS-61	0.04-0.28m	Sand and Gravel trace Silt/Clay	
	River	AS-62	0.28-0.41m	Sandy Gravel trace Silt/Clay	
Δ	River	AS-63	0.41-0.87m	Gravelly Silty/Clayey Sand	
\Diamond	River	AS-65	1.40-1.70m	Silty Sand some Clay some Gravel
