CCTV inspection report

Alexandria

Garry River Easement

13 december 2024

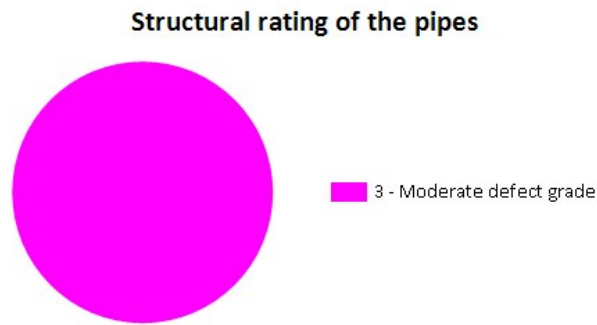
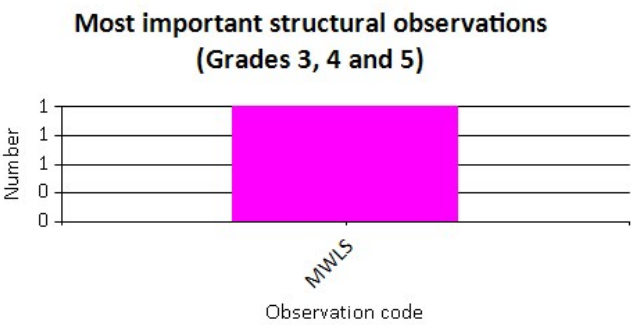
5. Structural rating

3 - Moderate defect grade (1 of 1 items)

Score	Quick	Index	Pipe	Upstream	Downstream	Street	Page
5	3121	2.5	50-40	50	40	Garry River Easement	10

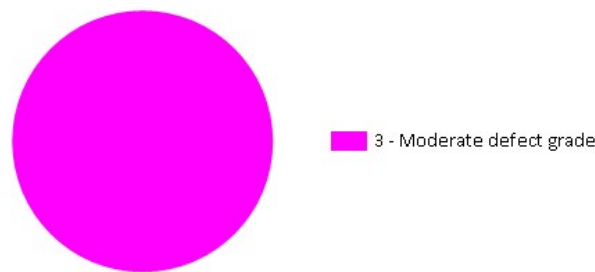
7. O&M rating

Operation and maintenance rating of the pipes

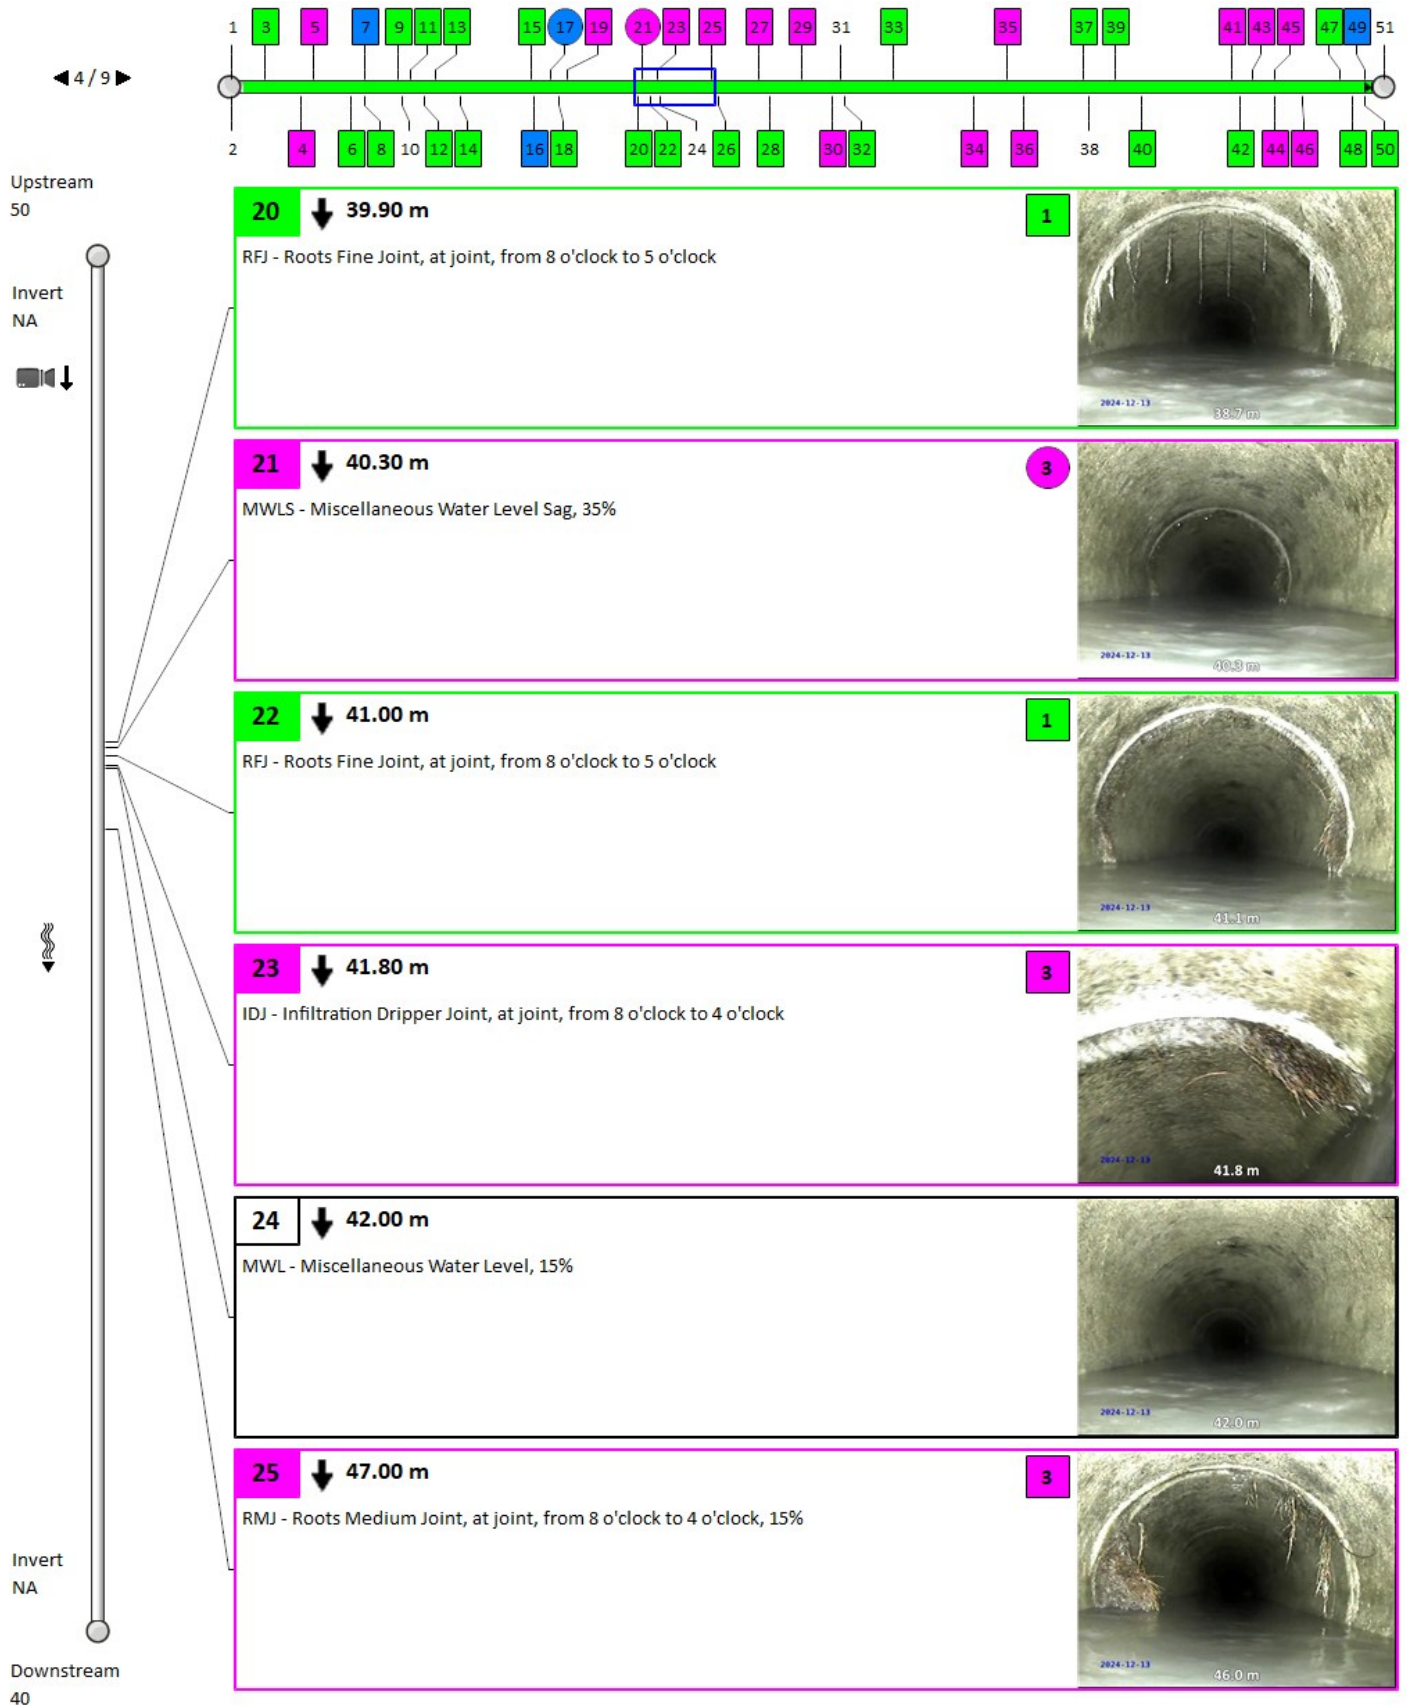
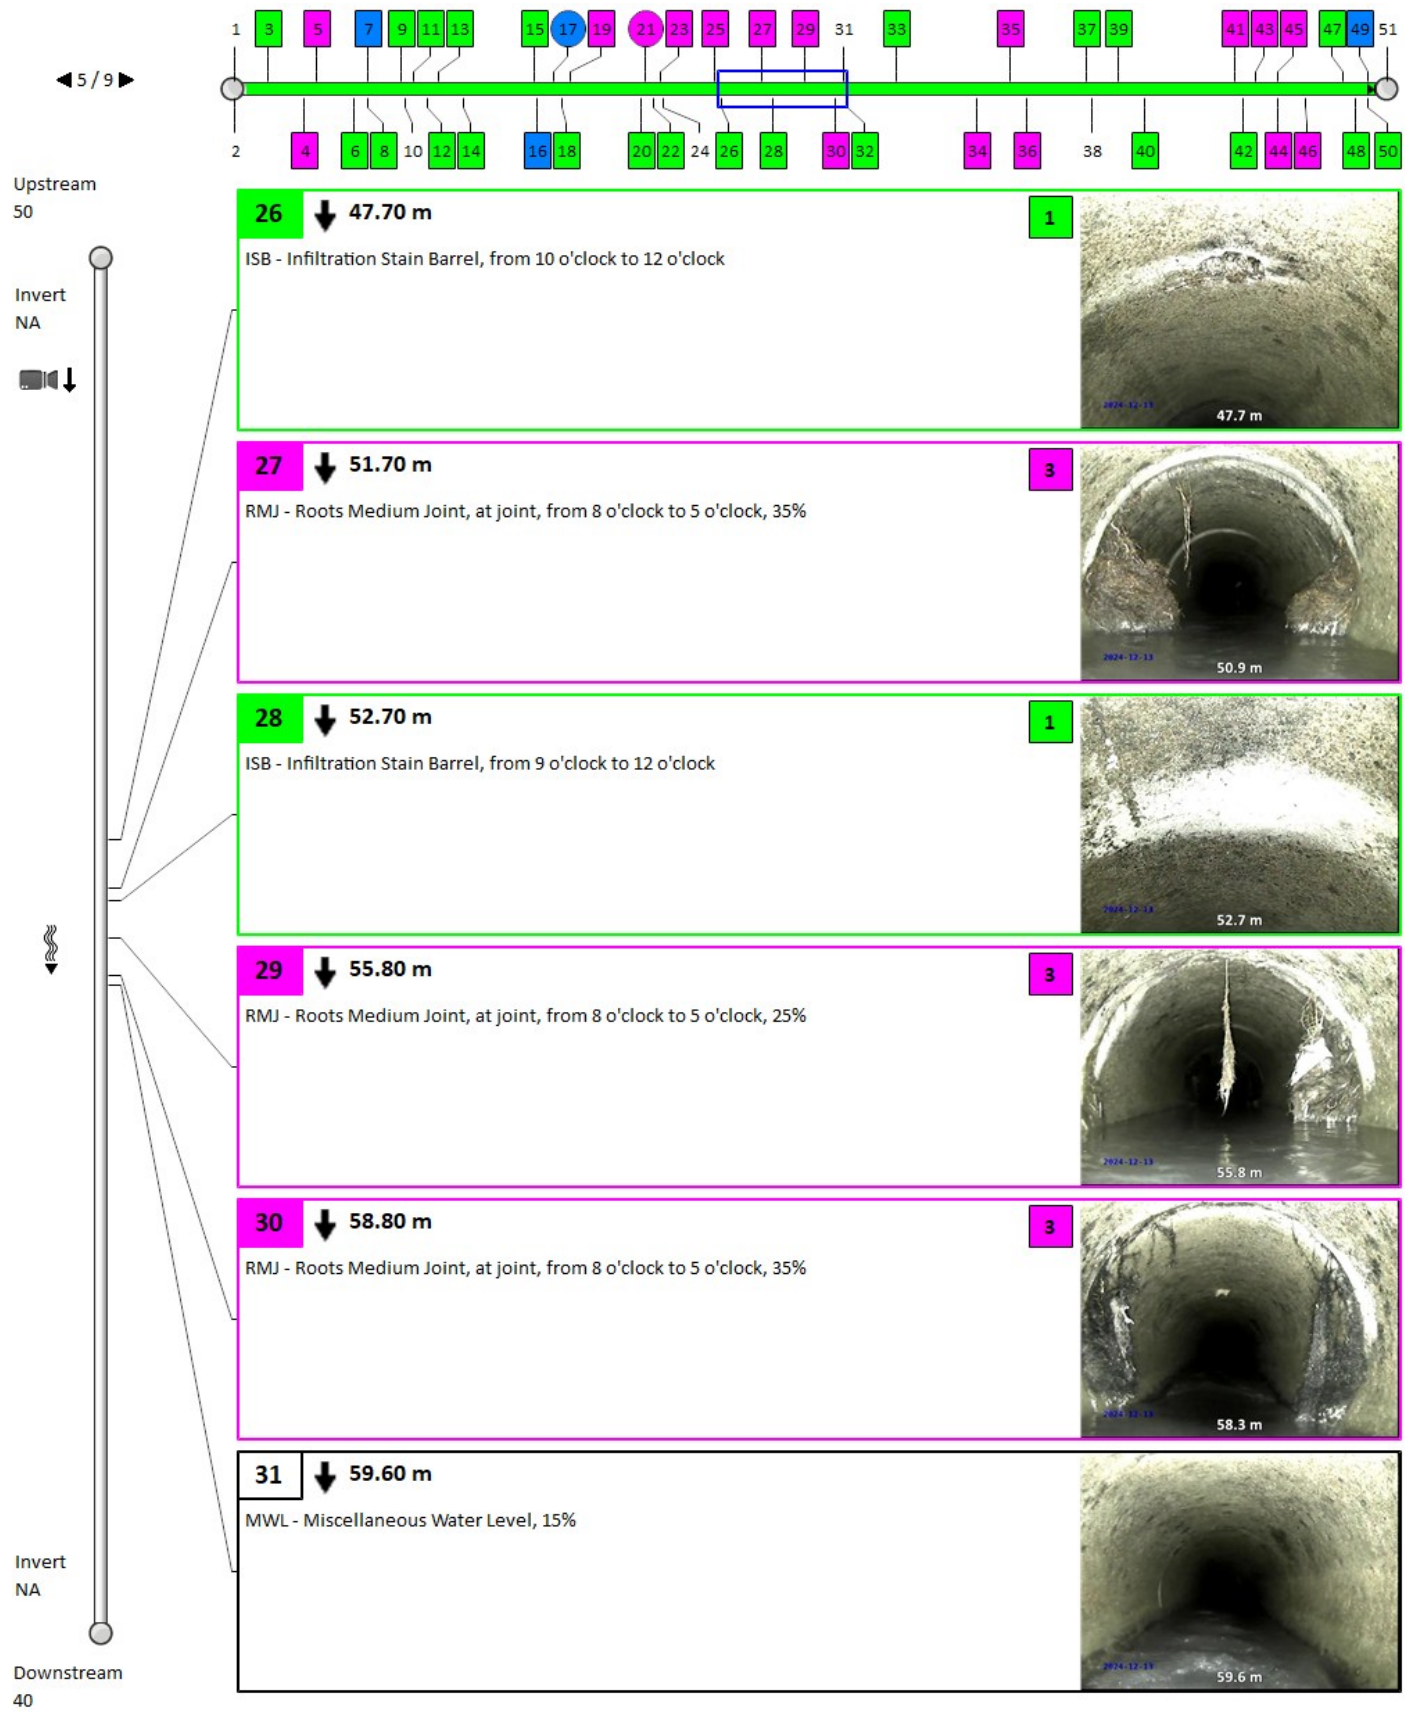
8. Pipe summary and condition details

Pipe: 50-40
Direction of flow: 50 --> 40

Pipe Use:	Sanitary Sewage Pipe	Surveyed Length:	112.8
Height:	600	Total length:	112.8
Width:		Joint length:	
Shape:	Circular	Rim/Inv.:	
Material:	Reinforced Concrete Pipe	Grade/Inv.:	
Lining:		Rim/Grade:	
Coating Method:		Rim/Inv.:	
Year Constructed:		Grade/Inv.:	
Year renewed:		Rim/Grade:

Structural rating	O&M rating	Overall rating	Failure
Peak: 3	Peak: 3	Peak: 3	Consequence:
Quick rating: 3121	Quick rating: 3B23	Quick rating: 3B24	Likelihood: 4
Score: 5	Score: 132	Score: 137	Risk:
Index: 2.5	Index: 1.4	Index: 1.4
